Case History

Analysis of generator rotor unbalance

by *George Murray and John Mucci*
Consolidated Edison
and *Scott Brier*
Sales Engineer
Bently Nevada Corporation

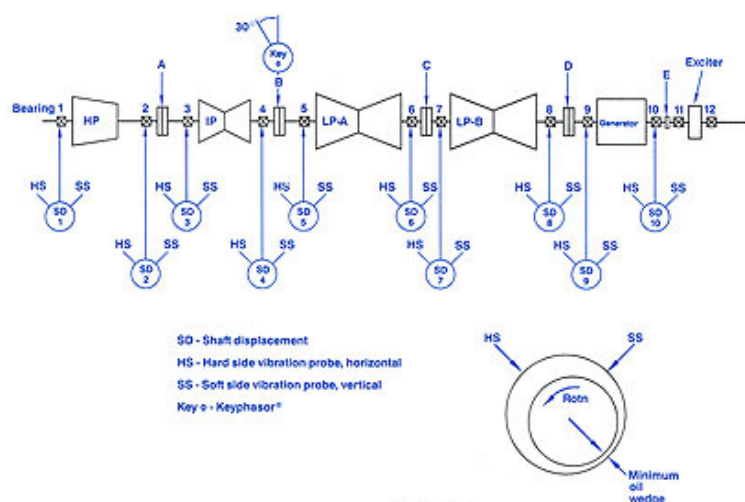
Figure 1
Turbogenerator machine train diagram

cross compound, 13 bearing machine, while Unit 3 is a 491 MW steam-driven, 12 bearing unit which uses a tandem design. Figure 1 shows Unit No. 3's machine train layout.

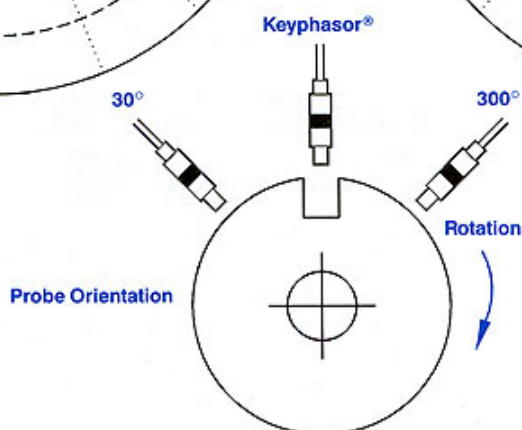
Generator Bearing No.10 Hard Side
Arthur Kill No.3 - 6/20/91 Roll Up

After working out the rub, the unit operated relatively trouble-free. On June 17, an overspeed trip test was scheduled for Unit No. 3. Because the generator rotor had responded favorably to previous balancing attempts, another balance shot was attempted by placing the correction weight in the alterex-to-generator coupling at a radius of 8 inches (203 mm). For a relatively small correction weight (5 ounces or 142 grams) at the alterex coupling, the results were totally unexpected. Generator vibration increased to levels that were not consistent with either the correction weight mass or previous responses (Figure 8).

This immediately alerted the station's operating personnel to a potential problem with the generator. However, it was decided to attempt another balance shot on June 20 to verify the inconsistent results. The results once again were inconsistent with the expected response (Figure 9). The decision to continue balancing was aided by having the unit's operating conditions continuously monitored.
